SAN FERNANDO, CALIFORNIA,
EARTHQUAKE OF
9 FEBRUARY 1971

GORDON B. OAKESHOTT, *Editor*
CALIFORNIA DIVISION OF MINES AND GEOLOGY

BULLETIN 196
California Division of Mines and Geology
Resources Building, Sacramento, California

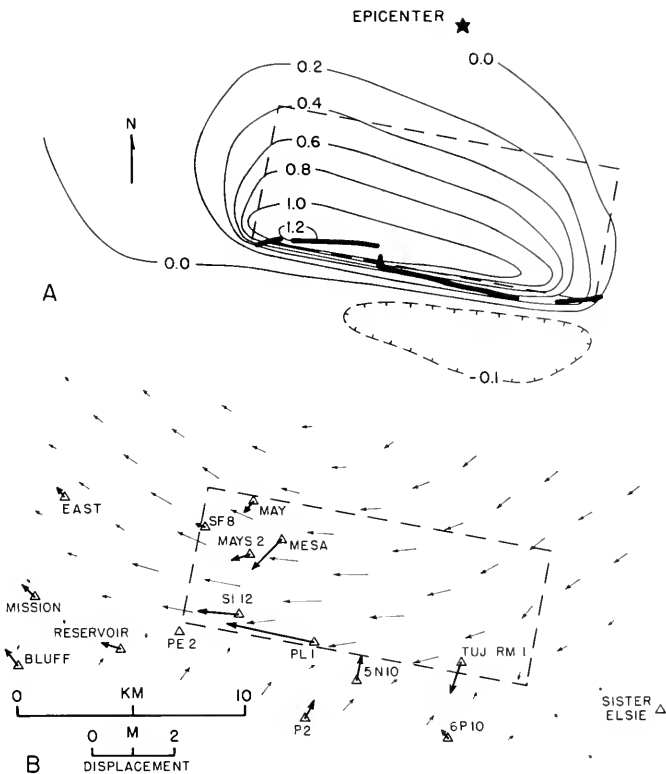
Figure 7A shows the changes in elevation predicted by the dislocation model. This calculated deformation can be compared to the observed deformation shown in figures 1 and 2 (notice that figure 2 covers only the stippled area in figure 7A). A north-south profile of elevation changes across the dislocation model is shown in figure 4C; this profile can be compared directly with the observed profiles in figures 4A and 4B. These comparisons show that although the dislocation model reproduces the gross features of the deformation, the details are not well modeled (for example, maximum observed uplift exceeds 2 m, but the maximum pre-

Figure 7. Deformation induced on the free surface by slip on the dislocation model described in table 3. A) The upper figure shows the vertical component of displacement in meters. Values plotted are differences between first observations on each line and subsequent observations (for example, 2-1 is the elevation determined in the second survey less the elevation determined in the first survey). The dashed rectangle is the projection of the fault model upon the free surface. The heavy lines along the south end of that rectangle show the approximate location of the San Fernando fault zone. The shaded rectangle shows the area covered by figure 2. B) The lower figure shows horizontal displacement (light arrows) induced on the free surface by slip on the dislocation model of table 3. The heavy arrows originating at triangles represent the observed displacement at triangulation stations in the area. The dashed rectangle represents the projection of the fault model upon the free surface.

It is reasonable to expect that the focus of the main shock of the San Fernando earthquake would lie on the fault plane. Yet it is clear from figure 7A that our model fault does not fulfill this expectation. In fact, the model fault would have to be almost twice as wide to reach the focus which lies at a depth of about 13 km and at a distance of 13 km N of the zone of tectonic rupture. Figure 4D shows a north-south profile of the vertical deformation expected for a fault of sufficient width to reach the earthquake focus. It is clear that the narrow fault model (figure 4C) is the better fit to the observed deformation; the wider fault model requires a more extensive north-south distribution of vertical deformation. The difficulty that simple fault models yield what are apparently too-narrow fault widths has been encountered before (for example, Savage and Hastie, 1969, p. 1943) and appears to be

Figure 7B shows the horizontal surface displacement predicted by the model fault of table 3. Also shown in that figure are the horizontal displacements of the triangulation stations listed in table 1 as inferred from the differences in the pre-earthquake and postearthquake surveys. Comparison of the two surveys, of

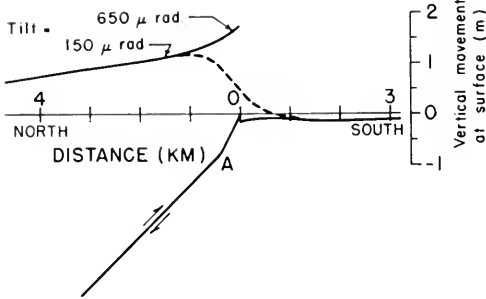
subsidiary fault (dip 65°N , 10°E , width 0.83 km, length 15 km, 2 m reverse slip, 2 m left slip) which joins the top of the main fault to the surface. The effect of the subsidiary fault is to increase the maximum uplift and tilt of the northern block very appreciably. Thus we suggest that the overall fit in figure 7 could be improved by introducing an imbricate structure near the toe of the thrust.

Figure 8. Profile of vertical displacement along a section perpendicular to strike induced by the fault model of table 3 supplemented by a short subsidiary fault (dip 65°, length 15 km, width 0.83 km, 2 m left-lateral and 2 m reverse slip) connecting the top of the main fault (A) to the free surface (O). The dashed line represents the vertical displacement produced by the main fault alone. This example suggests that the details of deformation near the toe of the thrust are dominated by the subsidiary faults.

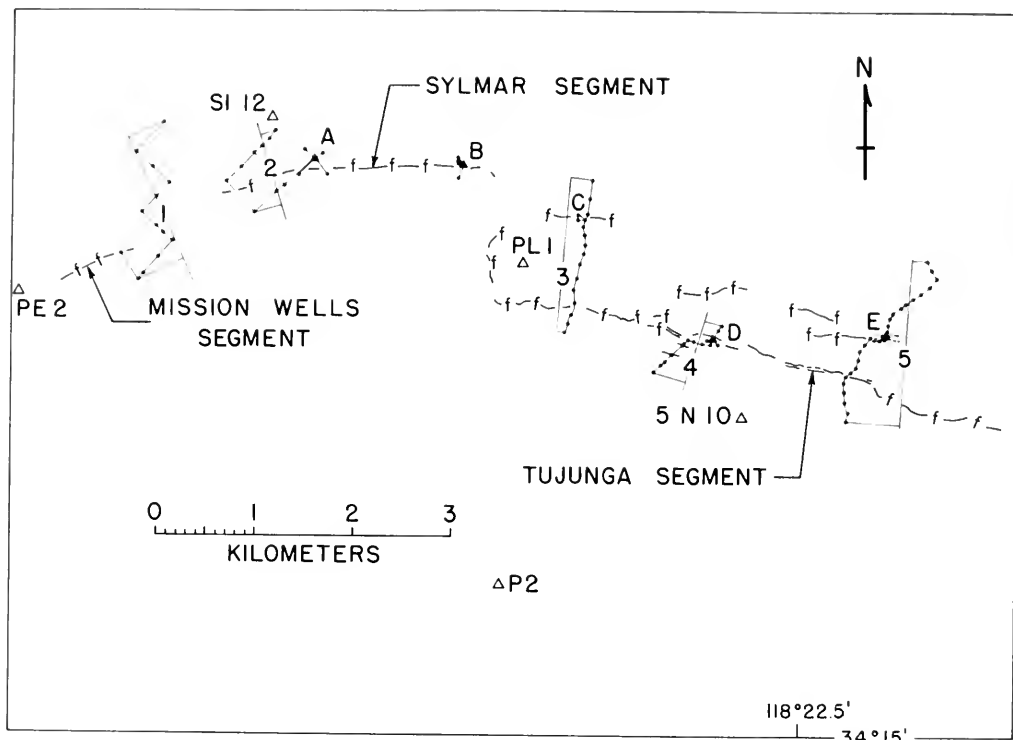
Significant changes in the small-scale arrays were recorded at only two sites indicated in figure 9 as locations D and E. At the Pierce array (site D), measurements on February 24 compared with initial measurements on February 11, 1971, showed that a monument 85 m north of the most prominent fault scarp rose 3.2 ± 0.6 mm while a monument 85 m south of the scarp rose 1.9 ± 0.6 mm (standard deviations) relative to the instrument station. Measurements at the Tujunga array (site E) on February 23 compared with initial measurements on February 12, 1971, showed that a monument on the north side of minor surface cracks rose 9.7 ± 0.5 mm while a monument about 90 m south of the cracks dropped 3.7 ± 0.3 mm relative to the instrument station which was also south of the cracks by about 28 m. No other significant changes were detected in the remeasurements of the small-scale arrays.

Figure 9. Index map of area surrounding the surface breaks showing the positions of monument arrays (A through E) and lines of repeated leveling (1 through 5) established for detection of displacements associated with afterslip.

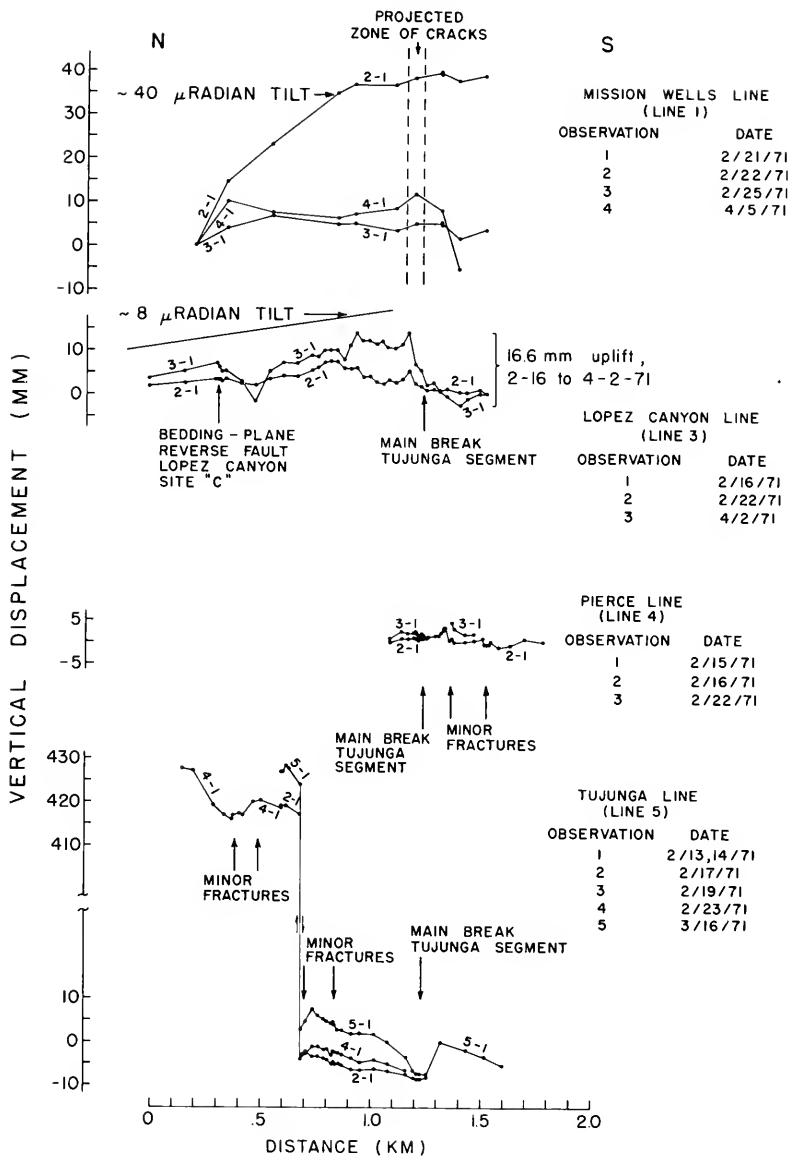
Figure 10. Profiles of vertical displacement along lines of repeated leveling following the main shock. Locations for the lines are given in figure 9. The displacement scale for the Tujuanga line is broken in order to show displacement detail on either side of the interval showing a 0.42 m elevation change.

what similar to those along the Mission Wells line. During the period February 16 to April 2, 1971, the vertical component of displacement across the main break of the Tujunga segment increased by about 17 mm while an additional uplift of about 5 mm occurred across a 200 m zone including the surface trace of the reverse fault discussed above. The northward tilt of the surface north of the main fault break was increased by about 8 microradians during the period of repeated measurements.

Level changes along the Pierce line (line 4 in figure 9) are marginally significant but are consistent in indicating continued upwarping or slight growth of south-facing scarps across a 200 m zone on the south side of the most prominent surface break produced during the initial rupture. The maximum increase in the uplift from south to north was about 5 mm from February 15 to February 25, 1971. Afterslip at this locality was thus barely detectable and must have been restricted to extremely shallow portions of subsidiary slip planes, since the main scarp showed no significant continued displacement and the uplift died out a short distance north of the zone of afterslip activity.

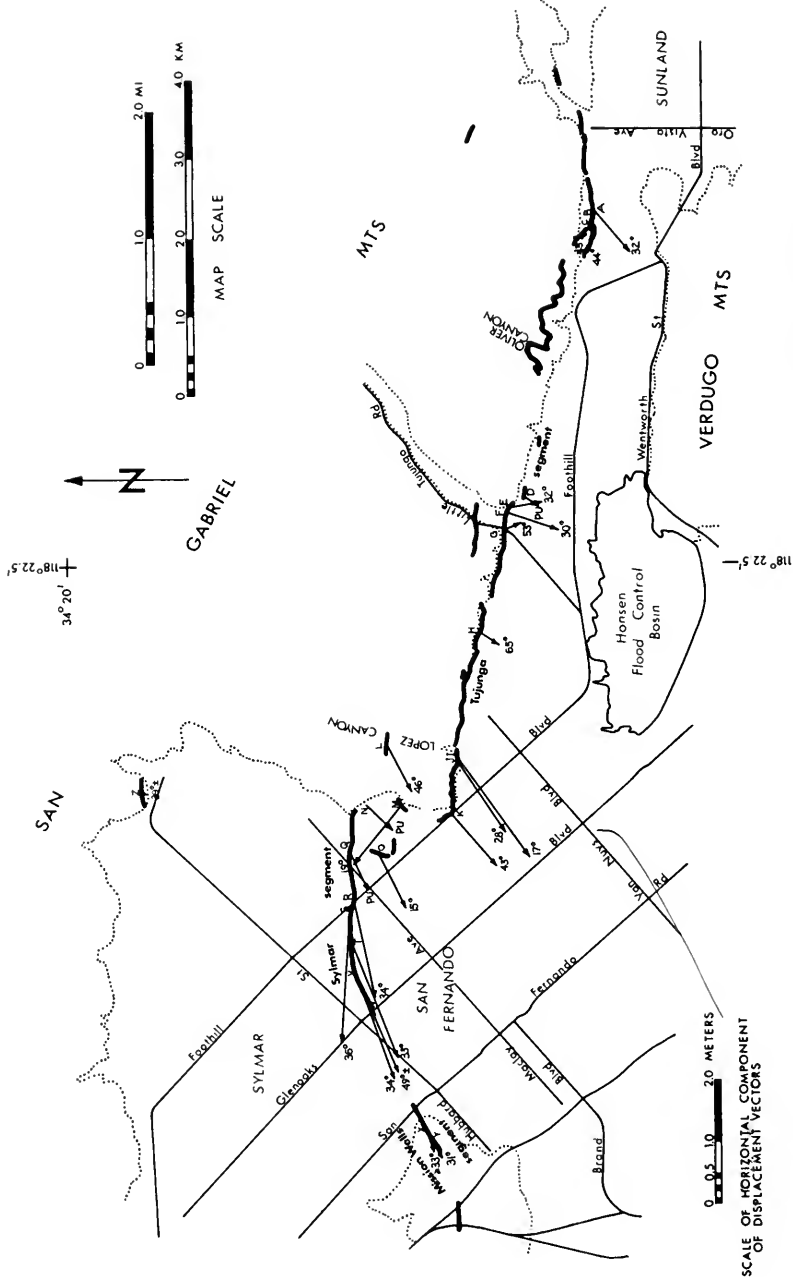
Figure 1. Movement of northern block with respect to the southern block, San Fernando earthquake of 1971. Length of arrows show horizontal component of calculated slip vectors (see table 1). Angle at head of arrow shows plunge of slip vector (plunge direction toward tail of arrow). Letters at tails of arrows identify vectors listed in table 1.

Three checks on the accuracy of the slip vectors are included among those shown on figure 1. Vector Y , on the Mission Wells segment, was determined at the location of an exposure of the fault surface that showed slickensides. The computed fault dip of $80^\circ N$ is close to the observed dip of 74° ; and the plunge of the computed slip vector, $31^\circ N 59^\circ E$, closely corresponds to the observed slickensides, which plunge $29^\circ N 55^\circ E$. Vector I west of Lopez Canyon provided a more limited check in that the fault dip exposed in a trench dug after the earthquake was used to calculate the slip vector. However, the computed plunge of the slip vector, $17^\circ N 55^\circ E$, corresponds closely to the plunge of slickensides observed in the trench, $20^\circ N 60^\circ E$. A third check, on vector L in upper Lopez Canyon, has been described previously by M. G. Bonilla (U.S. Geological Survey, 1971, p. 68-69); a moderate discrepancy between the computed slip vector and slickensides exposed there suggests that the latter formed during a previous episode of fault movement.

in the Tujunga segment (vector I), measured at the trailer park west of Lopez Canyon, was about 2.1 m. Its left-lateral component is about 2.4 times greater than the dip-slip component. Even larger slip (not indicated in figure 1) is suggested at a scarp 1.5 m high found farther east in Oliver Canyon (see Proctor and others, 1972, figures 10 and 12). A 20° dip on the fault there implies a slip vector of at least 4.4 m. However, Mr. R. Cowan, owner of the property, indicated that part of the present height of the scarp is pre-earthquake in age, so that slip there could not be accurately estimated. Although large slip is possible at Oliver Canyon, east of Lopez Canyon all measured slip vectors are smaller and generally less systematic than to the west. All but two vectors (B and C in Big Tujunga Wash) east of Lopez Canyon have a substantial compressional component normal to the fault trace. However, the sense of the lateral component changes from uniformly left-lateral in the western part to intermixed slightly right- or left-lateral vectors in the central part (vectors D through G) and back to uniformly left-lateral near the eastern terminus of ground rupture. Although nearly all of the vectors are consistent with southward overthrusting of the San Gabriel mountain mass relative to the valley, internal spreading and piling up in the overthrust block is also implied by the changes in sense of lateral components along the Tujunga segment. The two vectors that show predominantly strike-slip in Big Tujunga Wash (B and C) may reflect anomalous surface geometry of a northward-dipping thrust fault beneath the thick unconsolidated alluvium, despite the fact that the slip vectors indicate steep southward dip in the alluvial material. The sinuous traces of the faults there in fact suggest shallow-dipping slip surfaces.

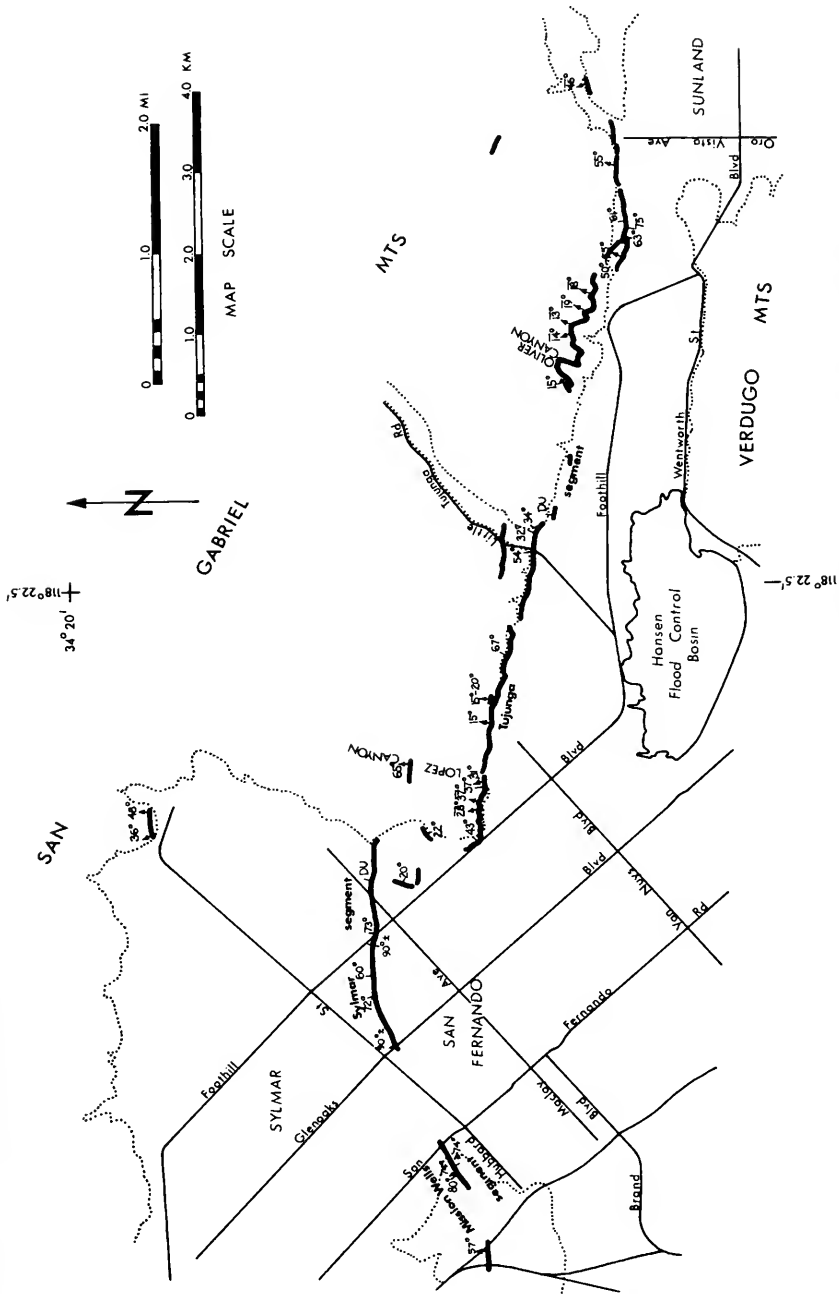
Figure 2. Dips of tectonic ruptures, San Fernando earthquake of 1971. Observed dips shown with arrow head on dip line. Bar over dip angle indicates average dip determined from trends of the fault trace over topography. Dips without arrow heads are calculated from slip vectors and fault strike. DU means dip unknown.

Angles of dip of the tectonic ruptures that have been measured in the field or inferred from the slip vectors are shown in figure 2. These dips generally suggest that most of the fault segments that moved during the earthquake are essentially bedding-plane faults where they emerge at the ground surface. This general relationship is shown by exposures of the fault and bedding along the Tujunga segment, by bedding exposed near the Sylmar and Mission Wells segments, as well as by regional bedding orientation relative to the overall trace of surface rupture. The array of inferred and observed fault dips suggests that the Mission Wells and Sylmar segments on the valley surface dip

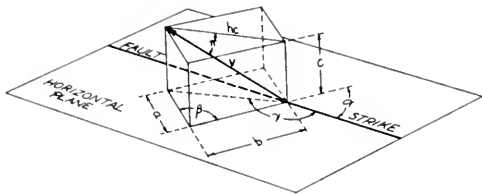
Figure 3. Three-dimensional view of a slip vector cell. Net slip vector V is cell diagonal. Apparent lateral separation a of linear feature at angle α from fault strike; apparent lateral separation b of second linear feature at angle β from first; vertical component of slip is c ; plunge angle of slip vector is γ ; azimuth angle of slip vector (measured from fault strike) is δ ; length of vectors shown in figure 1 corresponds to horizontal component of slip vector, hc .

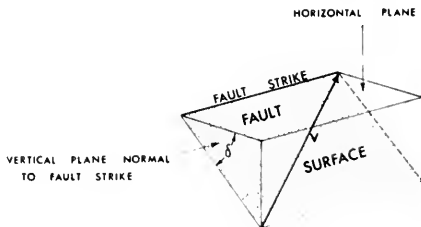
Figure 4. Relation of dip δ to slip vector V and fault strike. View from overhanging block.

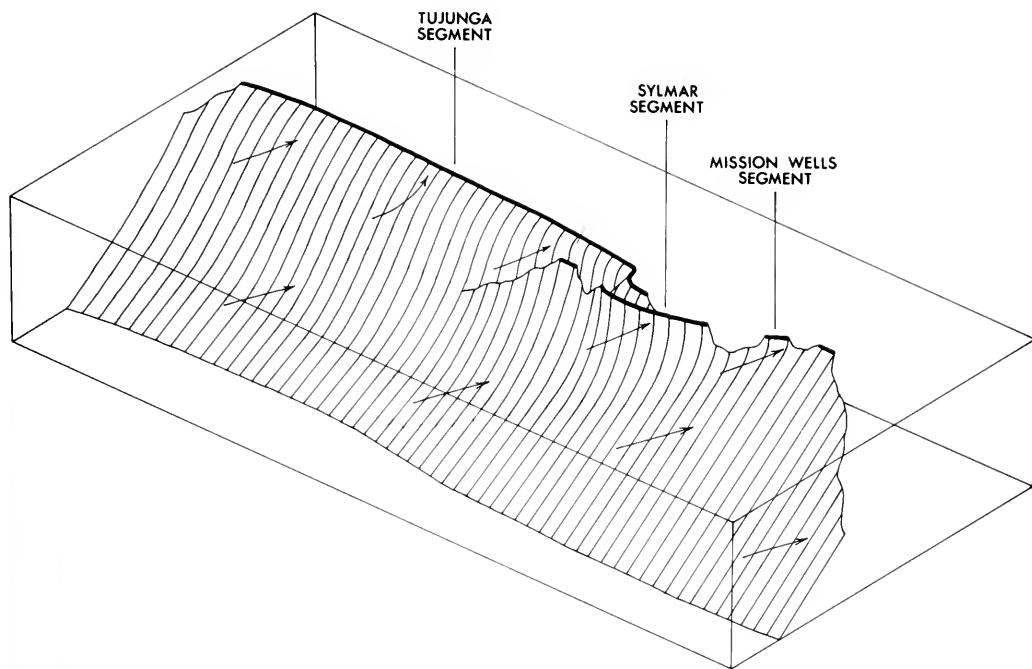
The shape of the slip surface along the eastern part of the Sylmar segment and along the Tujunga segment has been drawn to reflect downward curvature of bedding in rocks adjoining the faults. Exposures of the fault in Cenozoic sediments along the Tujunga segment indicate that the slip surface is essentially parallel to bedding (Kamb and others, 1971; U.S. Geological Survey, 1971; Barrows and others, this Bulletin). The regional strike of bedding along the front of the San Gabriel Mountains also parallels the trace of the Tujunga segment (see Oakeshott, 1958, plate 1; Metropolitan Water District, 1968). Assuming that the observed conformable relationship holds for at least a short distance downdip, the slip surface would abruptly steepen only a few hundred meters north of its trace. This steepening is indicated by the general increase in dip of bedding from about 30° at the range front to as much as 85° a short distance farther north (Oakeshott, 1958; Metropolitan Water District, 1968). However, it should be emphasized that parallelism of the slip surface and bedding probably does not continue to a very great depth, perhaps less than 1 or 2 km, because aftershock data suggest a net regional northward dip on the fault surface of about 35° (Allen and others, this Bulletin), whereas regional geology suggests that bedding is steep to much greater depths. Thus, the inclination of the deep part of the Tujunga segment shown in figure 5 probably is similar to that observed at the fault trace.

Figure 5. Generalized reconstruction of fault surface, San Fernando earthquake (view from northwest). Heavy lines show surface ruptures. Lines on fault surface drawn in direction normal to average trend of fault. Arrows on fault surface show approximate relative direction of slip of block north of fault.

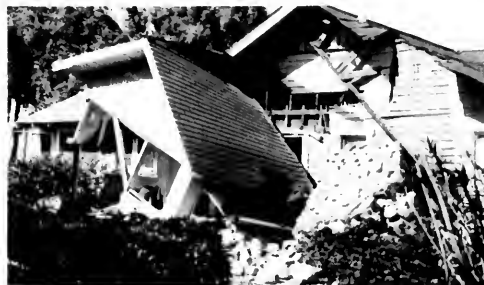
Photo 3. One of the many chimneys that collapsed. In this house, support for porch also fell. Photo courtesy of City of Los Angeles Department of Building and Safety.

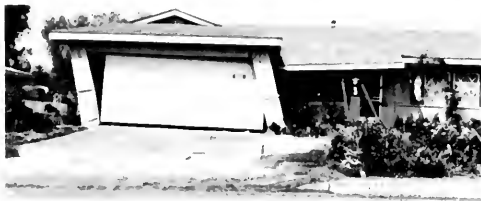
Photo 1. Example of damage incurred by residential structures in zone of ground rupture and intense shaking. Failure of garage was primarily a result of horizontal motion. Photo courtesy of City of Los Angeles Department of Building and Safety.

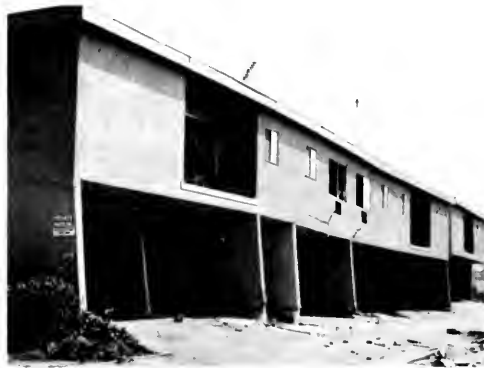
Photo 4. This apartment building, an Foothill Boulevard near Maclay Avenue, was damaged by both vertical ($21'' \pm$) and horizontal ($12'' \pm$) motion. Carport type of garage under second story dwelling is very susceptible to earthquake damage. Photo courtesy of City of Los Angeles Department of Building and Safety.

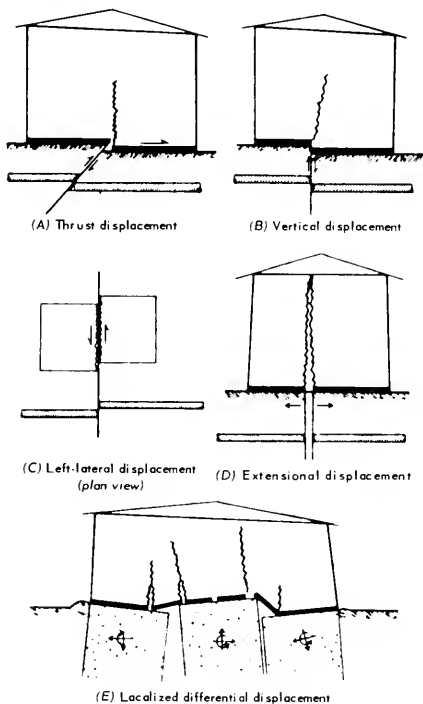
Figure 2. Sketches showing the type of damage associated with ground damage. (Figure 6 from U.S. Geological Survey Bulletin 733)

A similar zone of lurch cracks bounds the zone of fault-induced rupture between Foothill Boulevard and Hubbard Street. Apparently, when fault rupture occurs in an area mantled by alluvium, many of the ruptures extend to the surface. In addition, the energy released in the ruptured zone resulted in intensive shaking which, in turn, created lurch cracks.

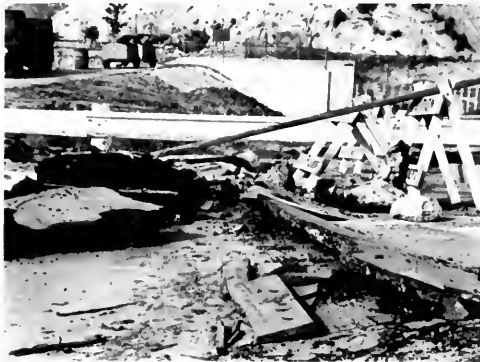
Photo 7. Example of street damage that affected travel to and from residential areas.

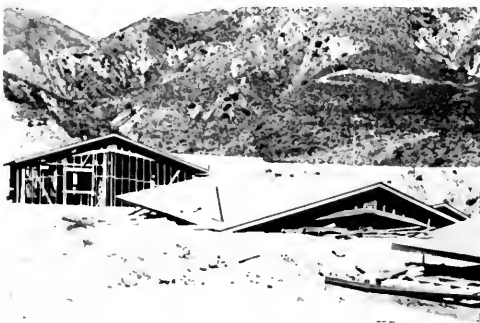
Photo 8. The structures in the foreground were framed only, with no lateral support. The structure in the background had part of the wire mesh placed in preparation for plastering; this difference in lateral support gave greater strength to the partly built structure, which survived better. Rojahn Street and Wallabi Avenue area. Photo courtesy of the City of Los Angeles Department of Building and Safety.

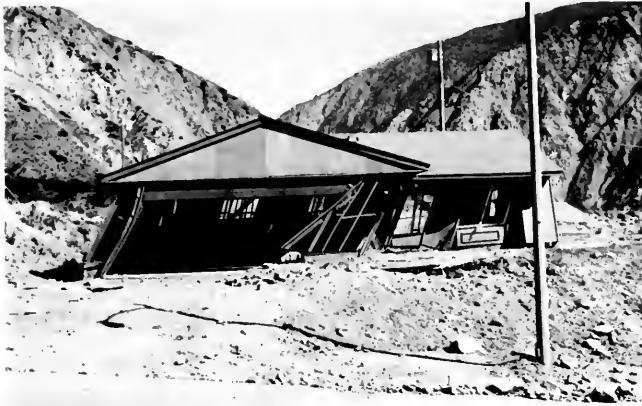
Photo 9. Partially completed structure with a good portion of sheathing and wire mesh placed. Rajah Street and Tucker Avenue area. Photo courtesy of the City of Los Angeles Department of Building and Safety.

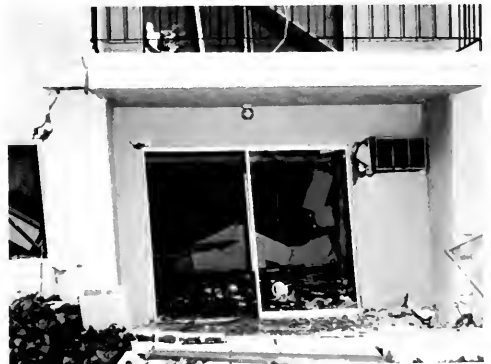
Photo 10. Portions of structures lacking adequate lateral strength sustained greater damage than those with adequate strength. Photo courtesy of the City of Los Angeles Department of Building and Safety.

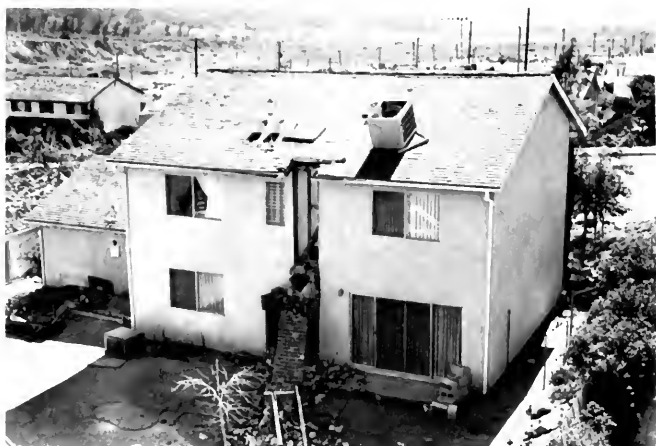
Photo 11. Newly completed structure with repairable damage. Here lateral support was sufficient to prevent collapse. Nevertheless, the chimney fell, windows shattered, and some walls were damaged. Photo courtesy of the City of Los Angeles Department of Building and Safety.

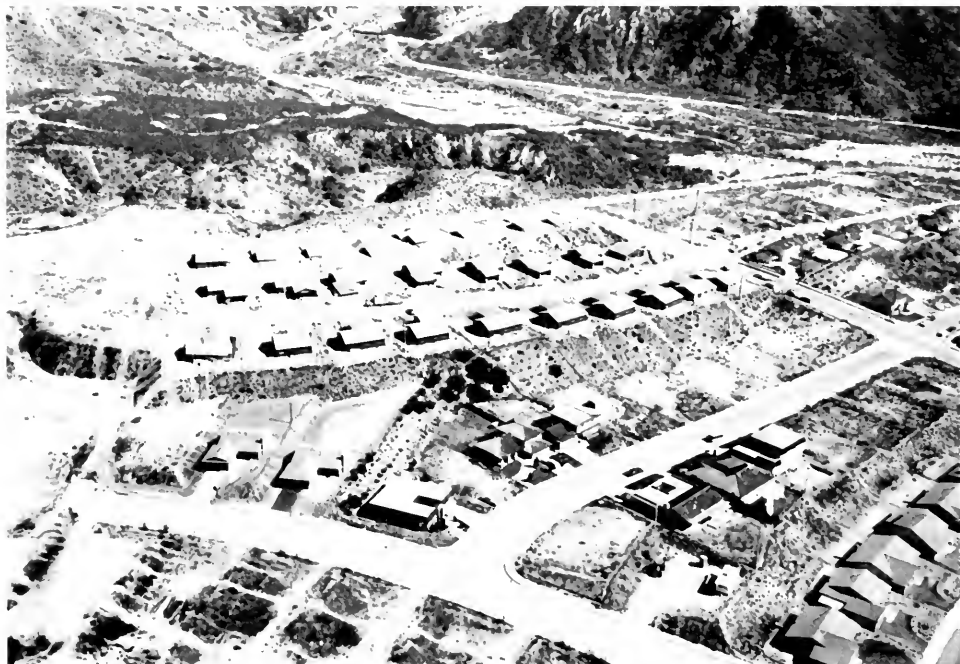
Photo 12. Houses being framed (photo 8) were located in top center; those partially completed in the left center and top left (photo 9); and those completed are in the foreground and far right (photos 10 and 11).

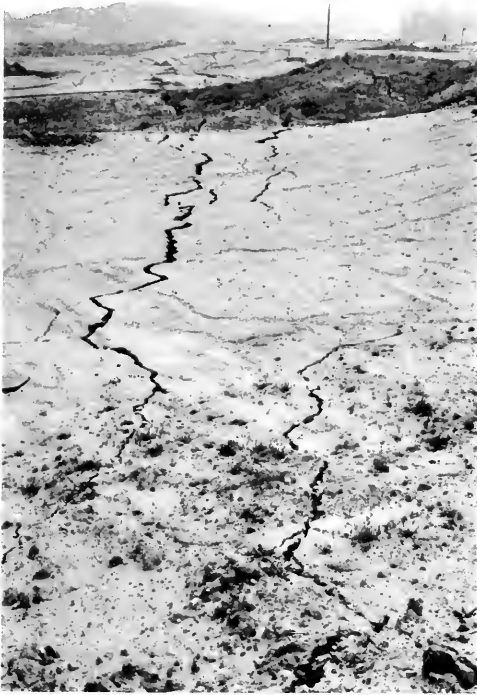
Photo 13. Ground cracks resulting from lurching. Courtesy of H. G. Anderson, Los Angeles Valley College.

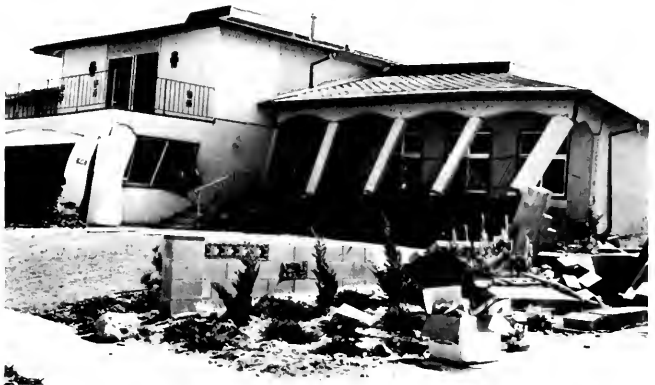
Photo 14. Two-story, split-level, residential structure (Almeiz Street) which sustained damage due to insufficient lateral support provided by ground garage opening and collapse of cripple supports under single-story portion. Courtesy of the City of Los Angeles Department of Building and Safety.

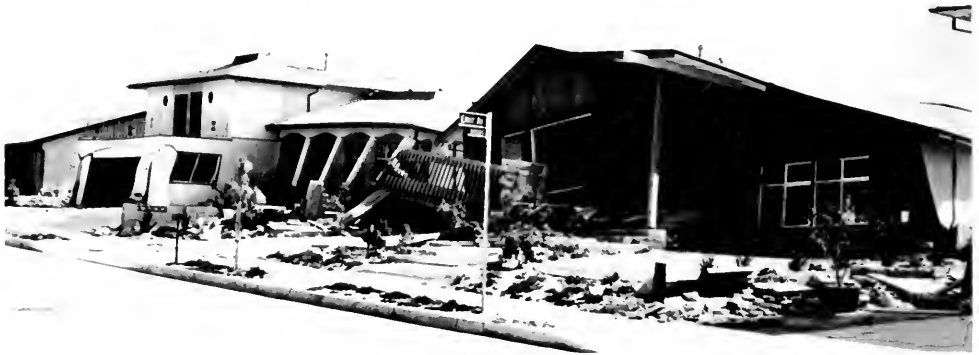
Photo 15. Examples of collapse of garage unit and support under single-story unit; house to left shown in photo 14.

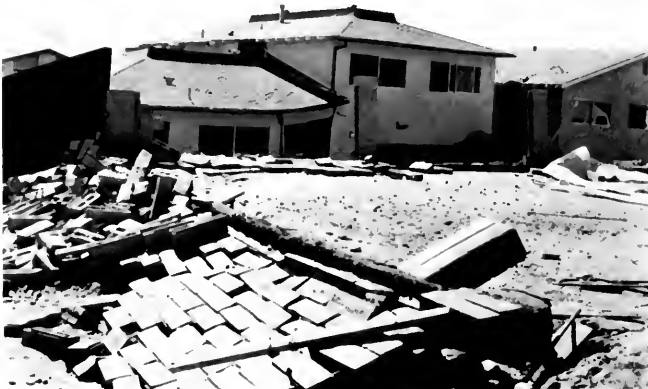
Photo 16. Example of collapse of single-story unit and pull-away between single and two-story portions (Almetz Street-Aldergrove Avenue). Courtesy of the City of Los Angeles Department of Building and Safety.

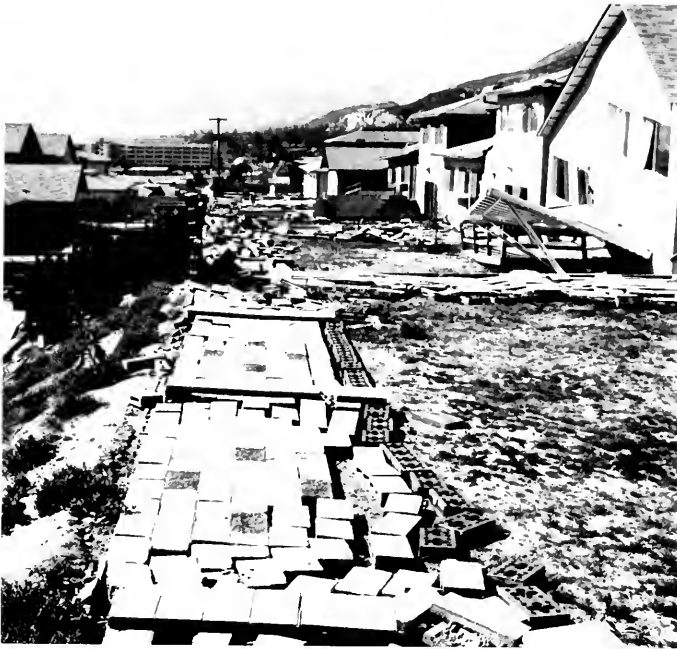
Photo 17. Example of garden wall failure (Almetz Street-Aldergrove Avenue). Note Olive View Hospital in background. Courtesy of Charles A. Yelverton.

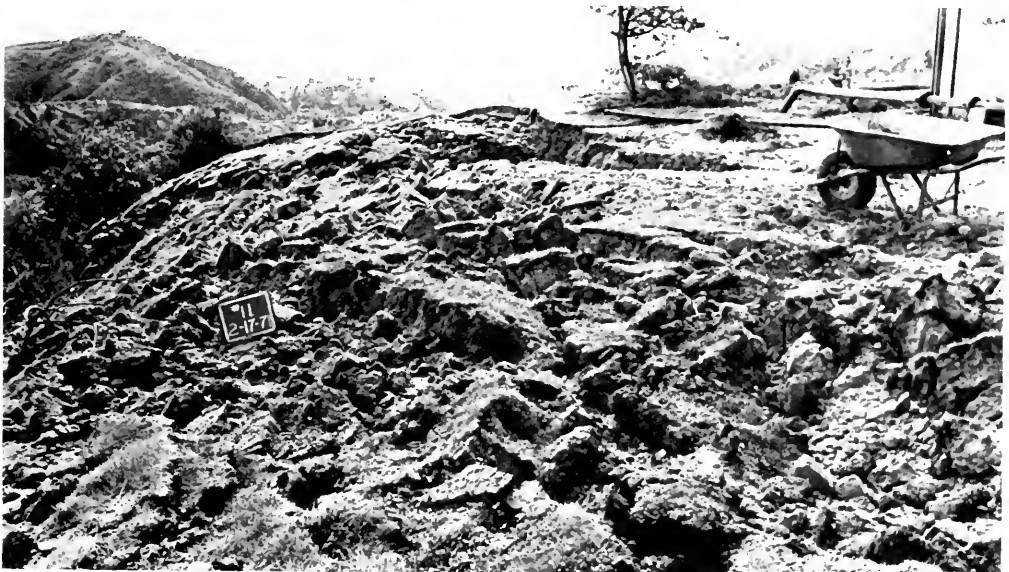
nada Hills and in various locations within the Saugus-Newhall region (see photo 18). The extent and degree of rupturing appears to be associated with the method of placing these fills. As an example, fills at Camp Karl Holten in Little Tujunga Canyon were severely damaged (see photo 19) as compared to no noticeable damage at the Hathaway School, also in Little Tujunga Canyon (see photo 20).

Photo 18. Ground cracks associated with settlement of fill related to consolidation of underlying alluvium and/or slopewash. Courtesy of the Engineering Geology Section, Los Angeles County Engineer's Office.

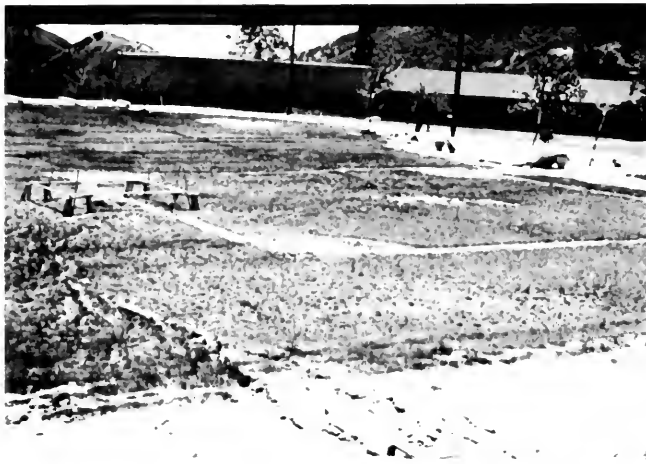
Photo 19. Ground cracks associated with failure of materials (alluvium) under fill materials.

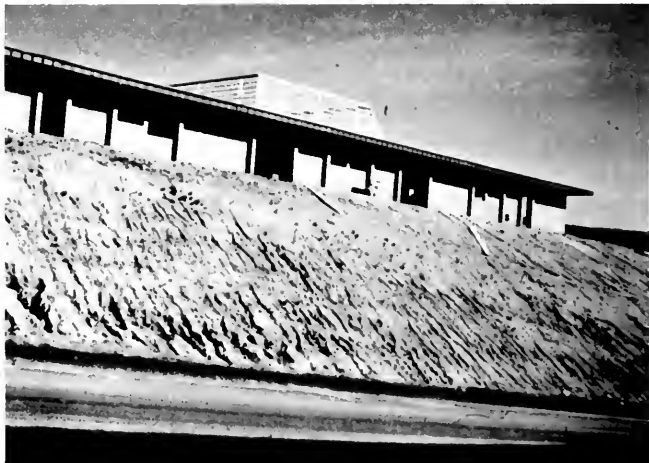
Photo 20. Rills from rainwash visible, but no cracks developed in fill materials or structures. Engineered fill placed under modern techniques and caides.

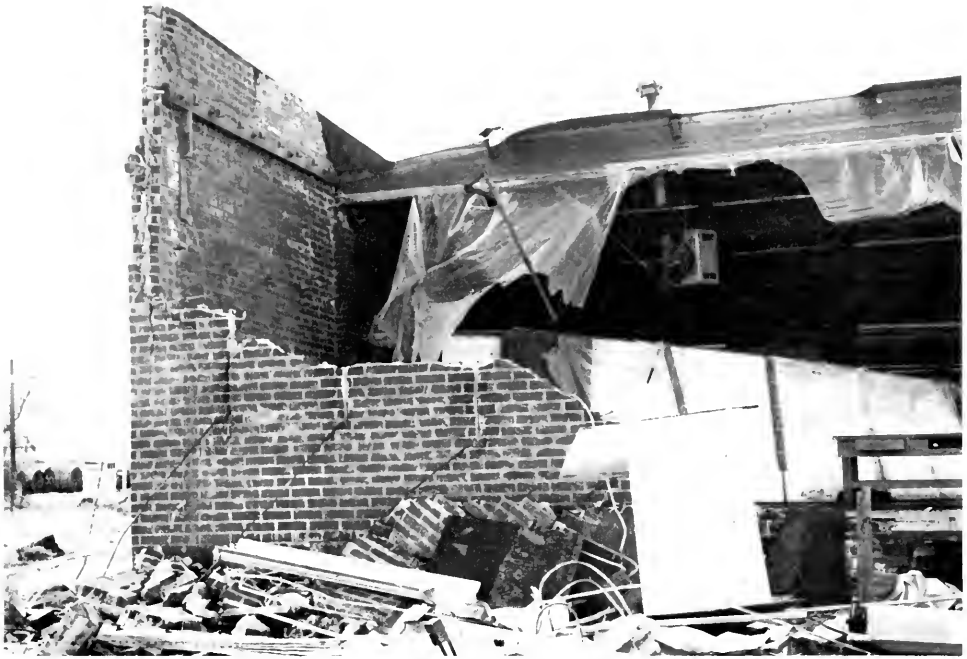
Photo 21. Masonry structure, as noted in this picture, generally sustained greater damage than wood frame structures.

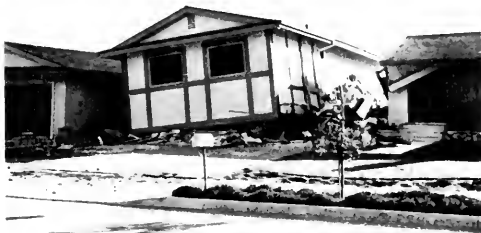
Photo 22. Example of two-story, split-level home where lack of structural support in garage portion allowed collapse. Courtesy of the City of Los Angeles Department of Building and Safety.

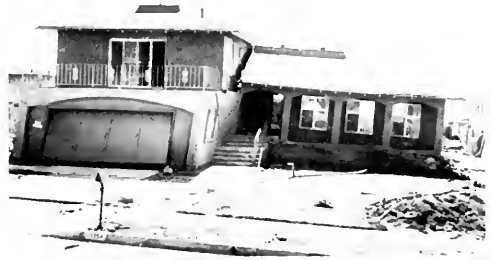
quate structural tie between the two-story portion and the single-story portion. A third weakness was the bracing of the cripple walls of the one-story portion which failed, allowing this portion to settle, thus removing support and allowing or causing failure of the two-story portion (see photos 23 and 24).

Photo 23. The one-story unit of this house settled and moved to the right following failure of the vertical (cripple) bracing between the floor and the footings. Courtesy of the City of Los Angeles Department of Building and Safety.

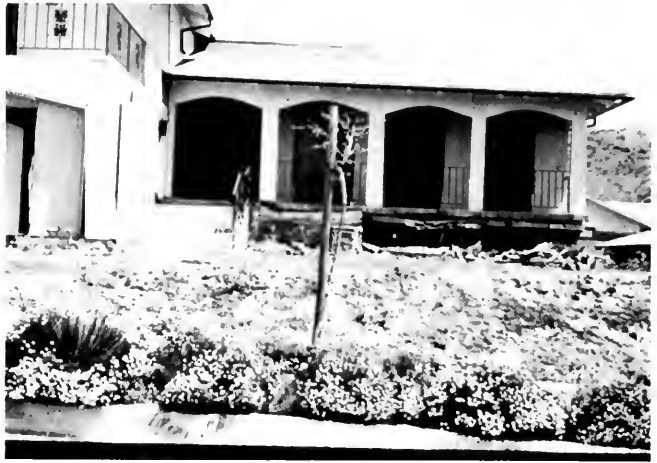
Photo 24. Note tilting and partial collapse of vertical bracings (cripples, lower right portion of structure) between floor and footing wall which allowed single-story unit to settle and move away from two-story unit.

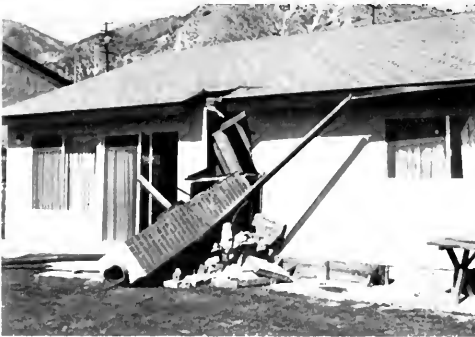
- A. Chimney anchorage: Pull-out strips; nails pulled out; and wood-tie failure occurred; chimney fell (see photo 25).

Photo 25. Collapse of chimneys was the most prominent damage to residential structures. Courtesy of Charles A. Yelverton.

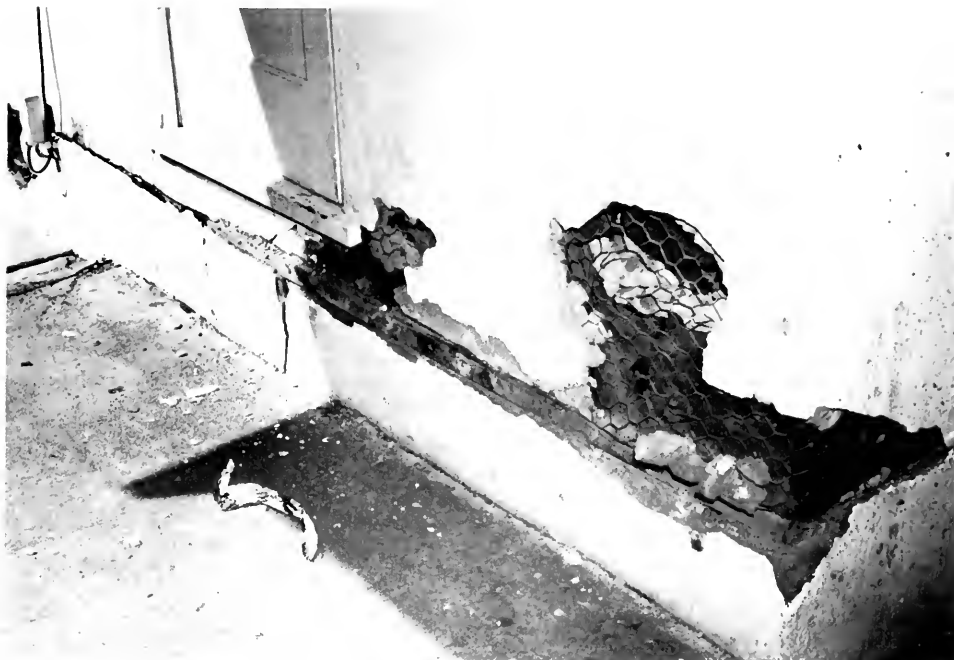
- B. Veneer anchorage in dwelling: Large pieces of veneer spalled off.
- C. Bracing in exterior walls and cripple walls of dwellings: Failures of walls indicated inadequate bracing (see photo 26).
- D. Cutting, notching, and boring of wood studs: Splitting or failure of wood studs indicated excessive cutting, notching, and boring of studs.
- E. Tile and cement shingle roof attachments: Considerable shifting of tile and cement shingles.
- F. Ties between different levels of wood frame construction and individual components, particularly in split-level construction and individual components: Numerous structural

Photo 26. Motion between footings and exterior walls was often common in the areas of intense shaking.

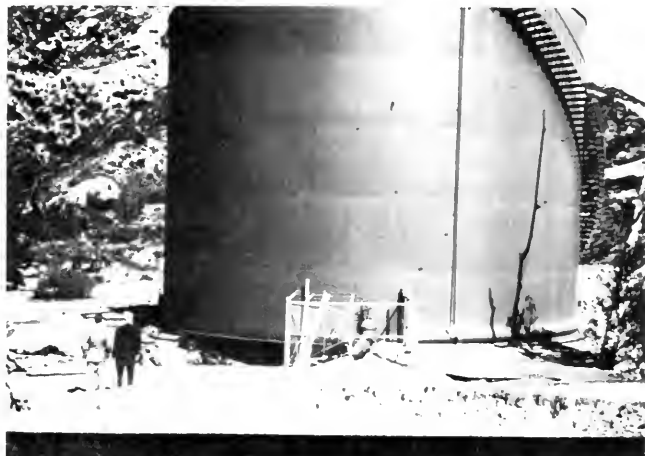
Several large water storage tanks were damaged. The most spectacular damage was to the tank at Olive View Hospital which developed a wrinkle at the base and ruptured as shown in photo 27. Others included the large Los Angeles Department of Water and Power Sesnon Tank in the Porter Ranch area and a Metropolitan Water District tank near the Jensen Filtration Plant. Almost all of the storage tanks in the Sylmar-San Fernando area were toppled, ruptured, or had their attachment lines severed.

Photo 27. Photograph of Olive View Hospital water storage tank. The wrinkle at the base resulted from earthquake motion and associated water-hammer effect and vertical motion of the tank. Base plate rupture appears on right side. (Wesley G. Bruer, State Geologist, and Mason L. Hill in left foreground.)

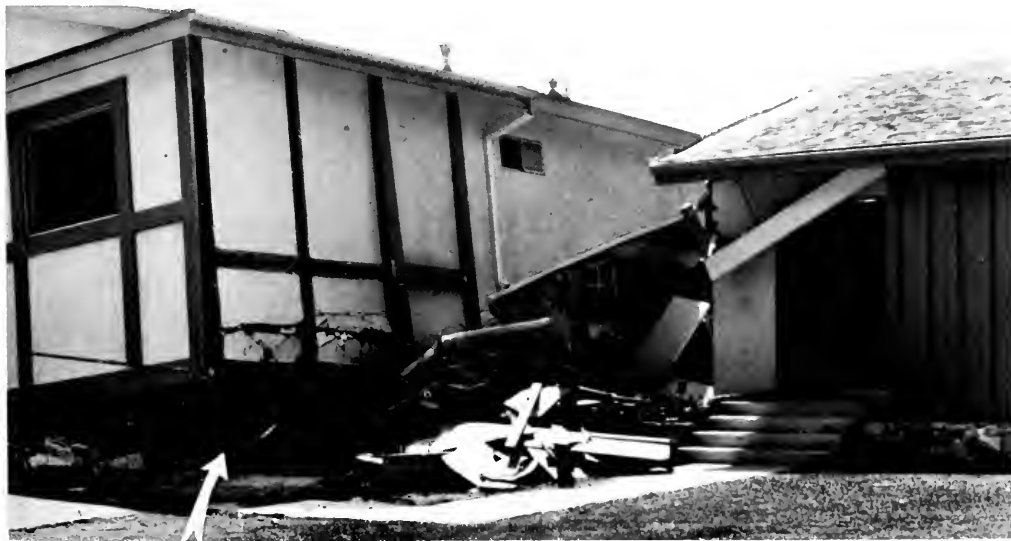
Photo 1. New split-level dwelling in the housing development southeast of Olive View Hospital. Garage under two-story level has collapsed (note crushed car).

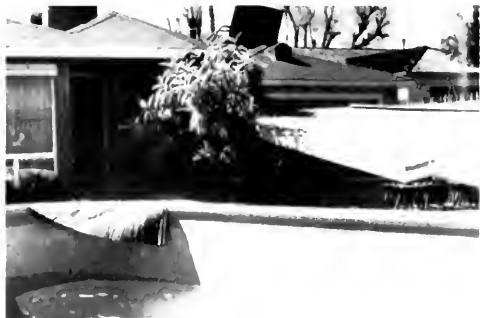
Photo 2. Well-constructed modern brick house on Warren Street, Sylmar. This dwelling was in the Sylmar zone of tectonic ruptures. Water sloshed out of swimming pool and inundated a basement room where a boy was sleeping.

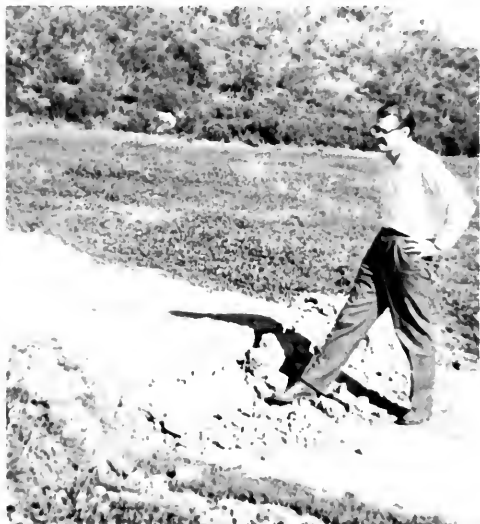
Photo 3. Fault scarp about 0.4 m high across dirt road in a farm field. One of a series of five parallel scarps with total vertical motion of about 0.8 m north of Van Nuys Boulevard along the foot of the hills. View to north. No lateral displacement.

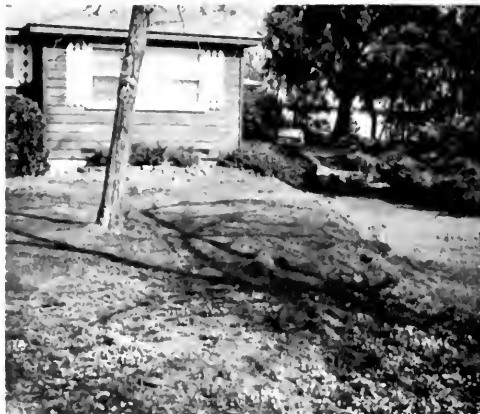
houses collapsed. No loss of life and few serious injuries resulted from this extraordinary ground motion. For example, the little-damaged house in photo 4 was right on the fault scarp.

Photo 4. Undamaged wood-frame home on Foothill Boulevard in Sylmar fault zone. East view. Edge of thrust zone runs a few feet from the house across the lawn.

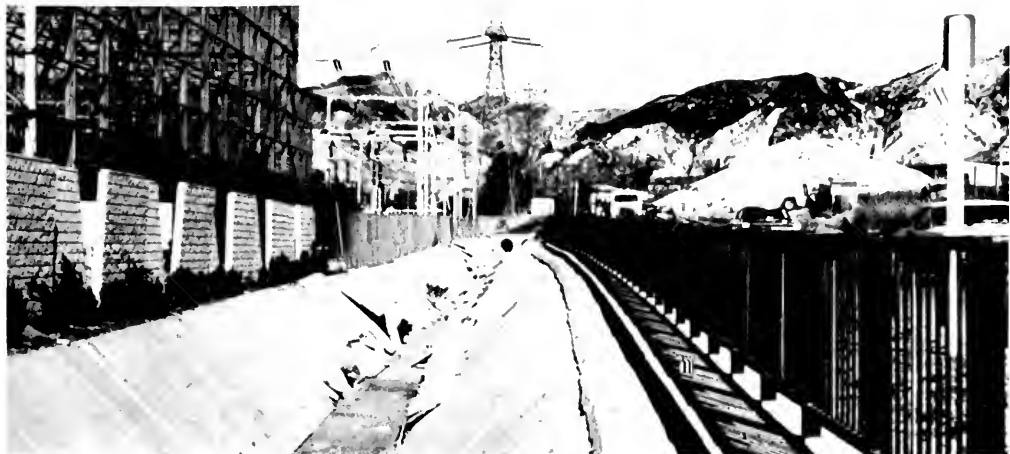
a linear zone of ground breakage running through the Juvenile facility across Highway 5 and Sepulveda Boulevard through Sylmar Converter Station across the top of Van Norman reservoir. Left-lateral displacement of about 0.5 m could be seen clearly along Sepulveda Boulevard and along a concrete canal parallel to it (photo 6). Secondly, the east-west zone of

Photo 6. Left-lateral displacement in concrete culvert (view northwest) parallel to Sylmar Converter Station and Sepulveda Road. Produced either by underlying tectonic displacement on the Mission Hills fault or by an extensive landslide.

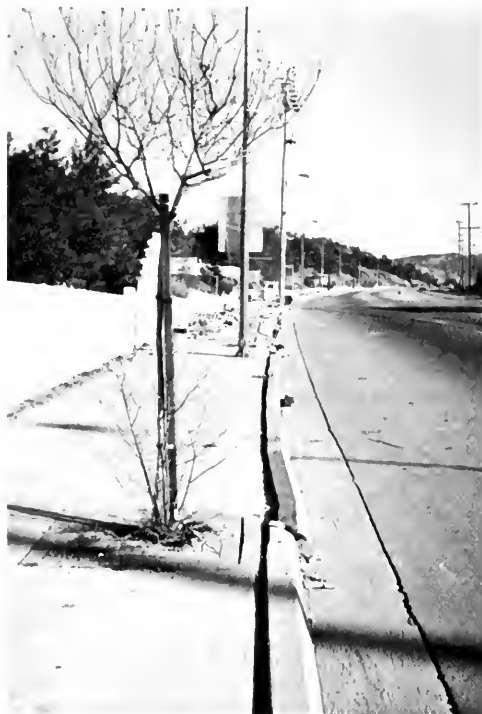
Photo 7. Damage to concrete block retaining walls, sidewalk, and gutter along Balboa Boulevard (west side).

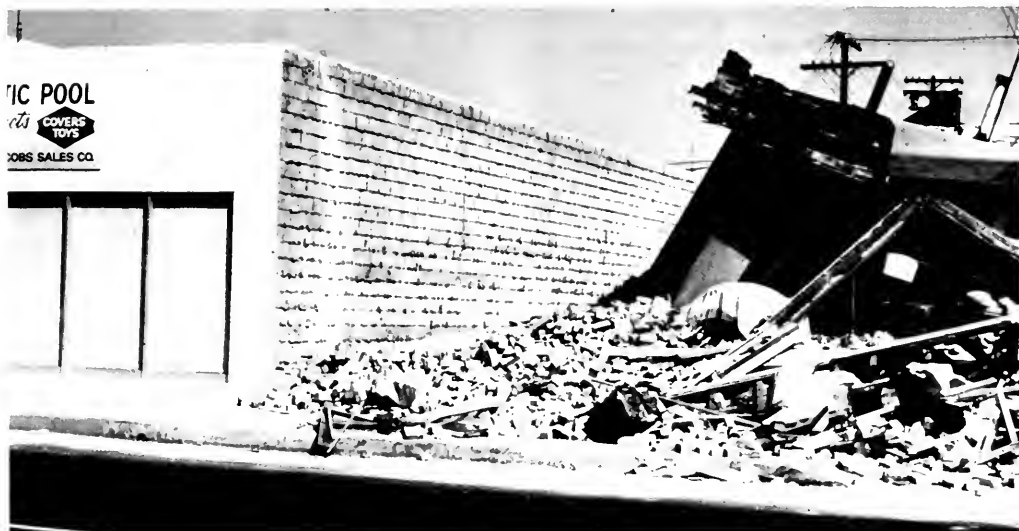
Photo 8. Contrast in response of masonry to seismic shaking. First Street in downtown San Fernando about 3 km south of Sylmar fault zone. A child was killed in the alder structure.

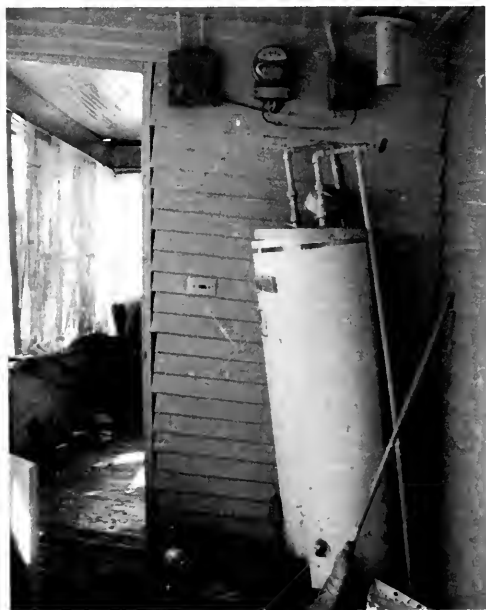
Photo 9. Frame distortion and interior damage in two-story wood-frame house on Orange Grove Avenue, San Fernando, within fault zone. Foundations moved considerably, but no injuries resulted.

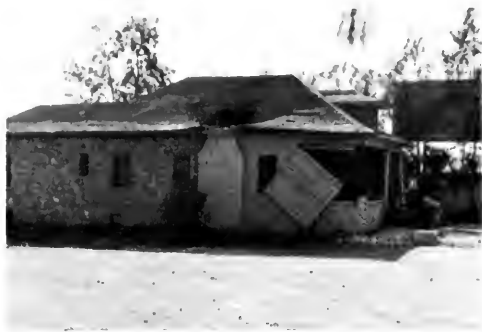
Photo 10. Unreinforced chimney which fell through roof of dwelling in San Fernando.

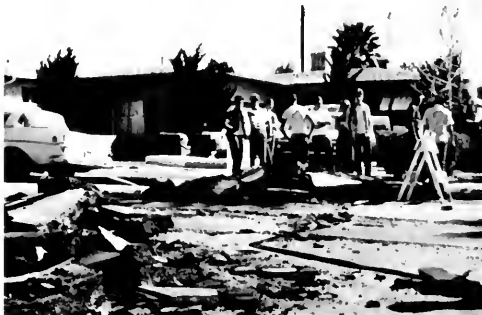
Photo 11. Day of the earthquake, looking east along thrust zone across Orange Grove Avenue, San Fernando. Wood-frame house straddles faulting in street and curbing. Note chimney, air conditioner, and TV antenna in place.

It is difficult to find any area of the megaseismic zone in which this description was exceeded. Even in the zone of severe thrust faulting in San Fernando, many wood-frame houses survived in quite surprising fashion (photo 11—note antennas and chimney standing). Thrust fault movement was responsible for severe damage to pavements in a narrow zone, yet structures nearby had little damage to foundations and little racking of frames (photo 12). There are, of course, more complexities of damage and felt reports than are covered by the present Modified Mercalli scale; this leads to marked differences in assessing the intensity level. The variation in description between

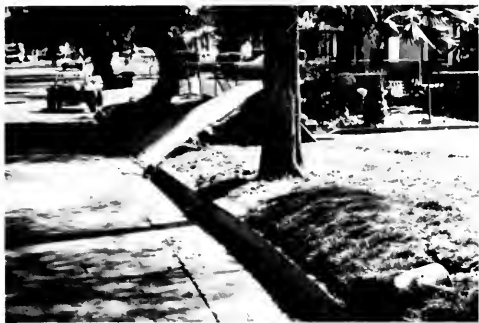
Photo 12. Adelphia Street in fault zone, San Fernando, view south-east. Spectacular left-lateral displacement of curbing accompanied by compression of driveway.
